Sea-Bird Electronics, Inc.
 13431 NE 20th Street
 Bellevue, WA 98005
 USA

APPLICATION NOTE NO. 75

Maintenance of SBE 5T, 5P, and 5M Pumps

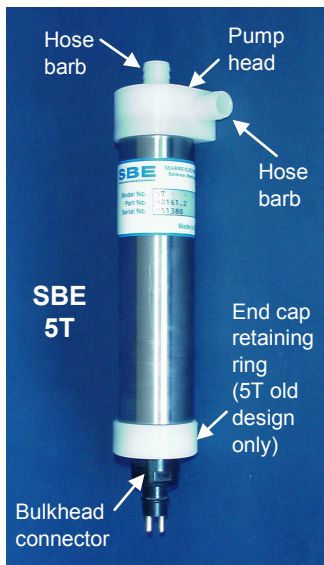
SBE 5T (old design, discontinued September 2011)

Note: **In September 2011, Sea-Bird changed the SBE 5T mechanical design;** the current design is easily differentiated from the old design because the current design does not have a retaining ring (see photos below). The old SBE 5T is opened from the end with the retaining ring and bulkhead connector; the current SBE 5T is opened from the end with the pump head.

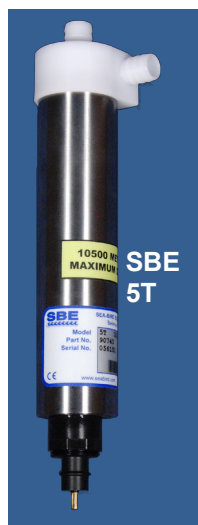
SBE 5T (current design)

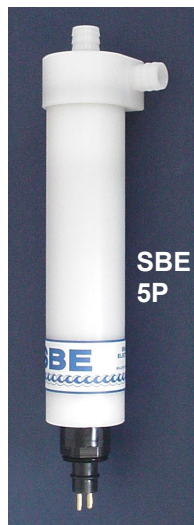
SBE 5P

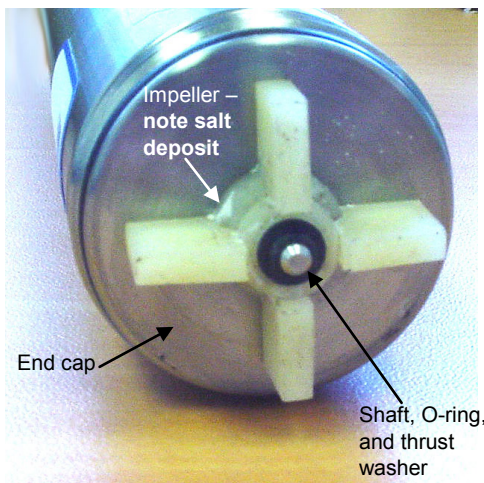
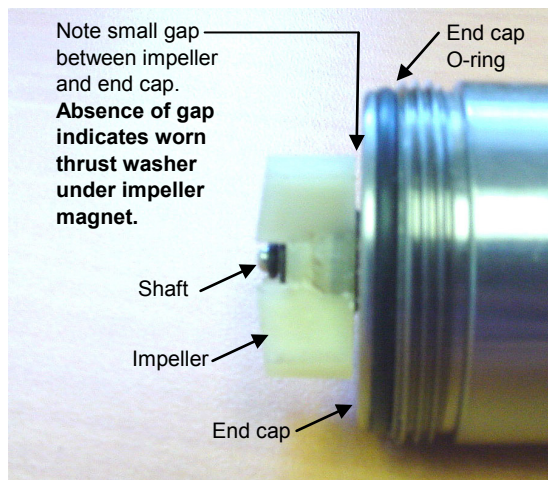
SBE 5T with Pump Head Removed

1. Unscrew the pump head from the housing.
2. Using clean, fresh water, thoroughly rinse the pump head and impeller.
3. Inspect the impeller for salt deposits. Clean any deposits with clean, fresh water and a toothbrush. Verify that the impeller can turn freely.
4. Inspect the shaft, and the O-ring and thrust washer holding the impeller on the shaft. There is another thrust washer underneath the impeller magnet, inside the housing. If this thrust washer is in good condition, you should observe a small gap between the bottom of the impeller and the end cap. If there is no gap, the thrust washer is worn and needs to be replaced (see *Yearly Maintenance for SBE 5T (old design)* for replacement procedure).

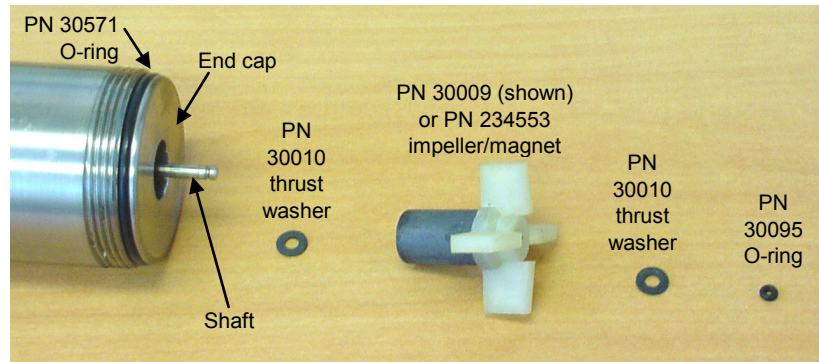
SBE 5T with Pump Head and Impeller Removed

Particularly in sandy coastal environments, the magnet may be worn down from abrasion. If necessary, replace the impeller / magnet assembly (PN 30009 or 234553).

Note: PN 30009 (with white impeller, as shown in photo) was replaced by PN 234553 (with black impeller) in 2012. These parts are interchangeable.

- A. Remove the O-ring from the shaft. A pair of tweezers works well for this.
- B. Pull the impeller and attached magnet off the shaft. The thrust washer above the impeller will come off at the same time. Inspect the impeller for salt build-up, and clean if necessary. Inspect the magnet for wear. Particularly in sandy coastal environments, the magnet may be worn down from abrasion. If necessary, replace the impeller / magnet assembly (PN 30009 or 234553).

- C. Remove the second thrust washer from the bottom of the shaft. A pair of tweezers works well for this.
 - D. Inspect the shaft for wear.
 - E. Rinse the shaft and depression in the housing with clean, fresh water. Allow to dry.

- F. Using new thrust washers (2 of PN 30010) and O-ring (PN 30095), replace the thrust washer and impeller / magnet on the shaft. Replace the other thrust washer and O-ring on the shaft, above the impeller, pushing hard with your fingertip to seat the thrust washer and O-ring in place.

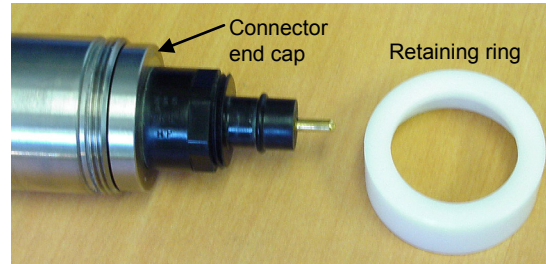
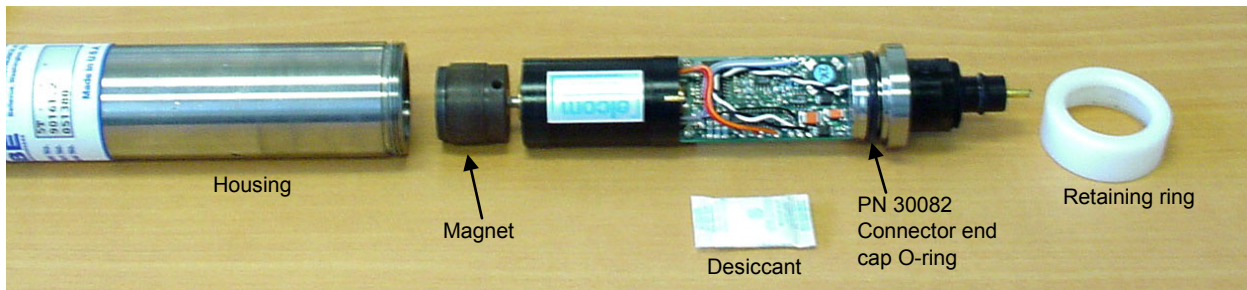
1. Unscrew the connector end cap retaining ring. Install a 2-pin dummy plug with locking sleeve over the bulkhead connector to provide a good grip and protect the connector pins. Rotate the end cap back and forth while carefully pulling the end cap away from the housing. Pull out the end cap and attached electronics from the housing.

2. Verify that the magnet can spin freely and is not broken or damaged.
3. Look for other signs of damage on the electronics.
4. Inspect the connector end cap O-ring and the mating surface in the housing for dirt, nicks, and cuts. Clean as necessary. If the O-ring or mating surface is damaged, return the pump to Sea-Bird for repairs.

5. Apply a light coat of O-ring lubricant (Parker Super O Lube) to the O-ring and mating surfaces. Gently place a **new desiccant bag** (PN 30558 – 1 gram) on the electronics (see *Application Note 71* for desiccant use and regeneration). Reinstall the electronics in the housing, until the O-ring has fully seated. Reinstall the retaining ring on the connector end cap.

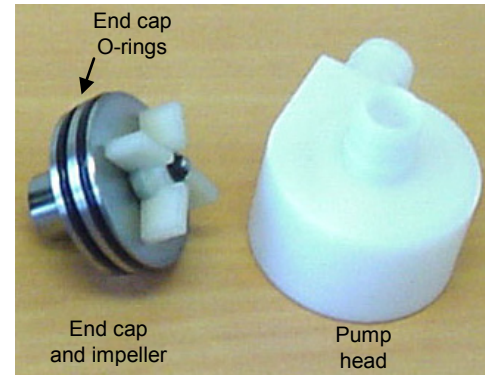
CAUTION: Remove the end cap and impeller from the housing before cleaning the impeller. The end cap O-rings seal the electronics chamber. The end cap may walk out of the housing after the pump head is removed, allowing water to enter the electronics chamber if you clean the impeller without first removing the end cap from the housing.

1. Unscrew the pump head from the housing.
2. Pull out the end cap from the housing.
3. Using clean, fresh water, thoroughly rinse the pump head and impeller.

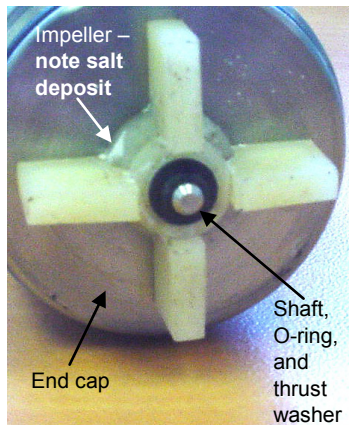
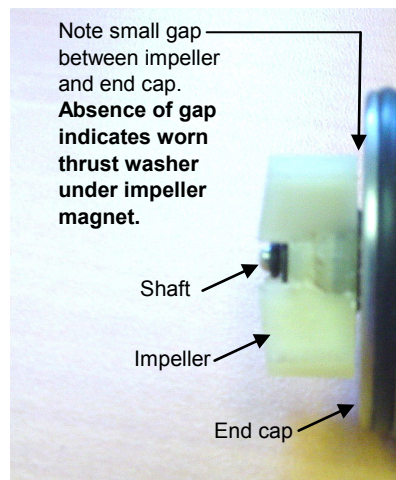
SBE 5M, 5P, or 5T with Pump Head Removed

4. Inspect the impeller for salt deposits. Clean any deposits with clean, fresh water and a toothbrush. Verify that the impeller can turn freely.
5. Inspect the shaft, and the O-ring and thrust washer holding the impeller on the shaft. There is another thrust washer underneath the impeller magnet, inside the housing. If this thrust washer is in good condition, you should observe a small gap between the bottom of the impeller and the end cap. If there is no gap, the thrust washer is worn and needs to be replaced (see *Yearly Maintenance for SBE 5M, 5P, or 5T (current design, no retaining ring)* for replacement procedure).

6. Apply a light coat of O-ring lubricant (Parker Super O Lube) to the O-ring and mating surfaces. Reinstall the end cap in the housing, carefully aligning the end cap with the housing and pushing hard on the end cap to seat the first O-ring in the housing (only 1 O-ring should now be visible).

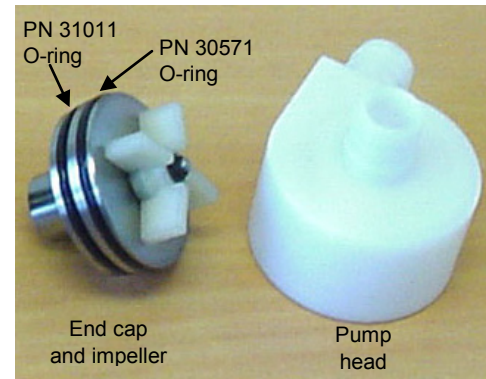
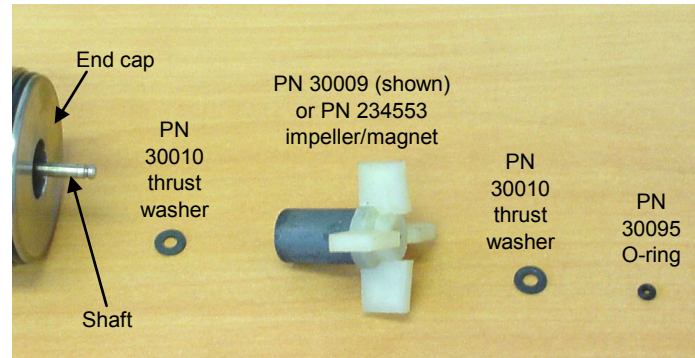
SBE 5M, 5P, or 5T with Pump Head and Impeller Removed

- A. Remove the O-ring from the shaft. A pair of tweezers works well for this.
 - B. Pull the impeller and attached magnet off the shaft. The thrust washer above the impeller will come off at the same time. Inspect the impeller for salt build-up, and clean if necessary. Inspect the magnet for wear. Particularly in sandy coastal environments, the magnet may be worn down from abrasion. If necessary, replace the impeller / magnet assembly (PN 30009 or 234553).
- Note: PN 30009 (with white impeller, as shown in photo) was replaced by PN 234553 (with black impeller) in 2012. These parts are interchangeable.

- C. Remove the second thrust washer from the bottom of the shaft. A pair of tweezers works well for this.
- D. Inspect the shaft for wear.
- E. Rinse the shaft and depression in the housing with clean, fresh water. Allow to dry.
- F. Using new thrust washers (2 of PN 30010) and O-ring (PN 30095), replace the thrust washer and impeller / magnet on the shaft. Replace the other thrust washer and O-ring on the shaft, above the impeller, pushing hard with your fingertip to seat the thrust washer and O-ring in place.

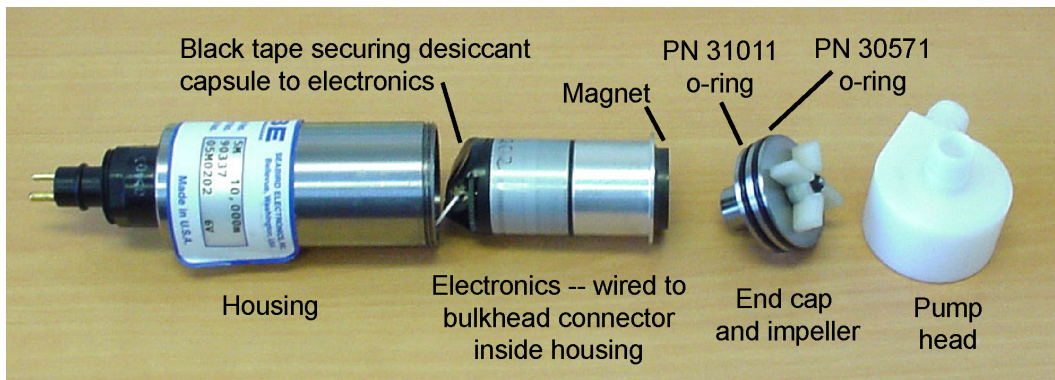
SBE 5M with Electronics Removed (titanium version shown; plastic version similar)

1. Unscrew the pump head from the housing.
2. Pull out the end cap from the housing.
3. Pull out the electronics from the housing. Note that the electronics are wired to the bulkhead connector inside the housing.

- A. Apply a light coat of O-ring lubricant (Parker Super O Lube) to the O-ring and mating surfaces.
 - B. **SBE 5M** – Gently place a **new desiccant capsule** (PN 31044 – 0.4 gram) on the electronics, and replace the black tape to secure it in place.
SBE 5P or 5T - Gently place a **new desiccant bag** (PN 30558 – 1 gram) on the electronics.
 (see *Application Note 71* for desiccant use and regeneration).

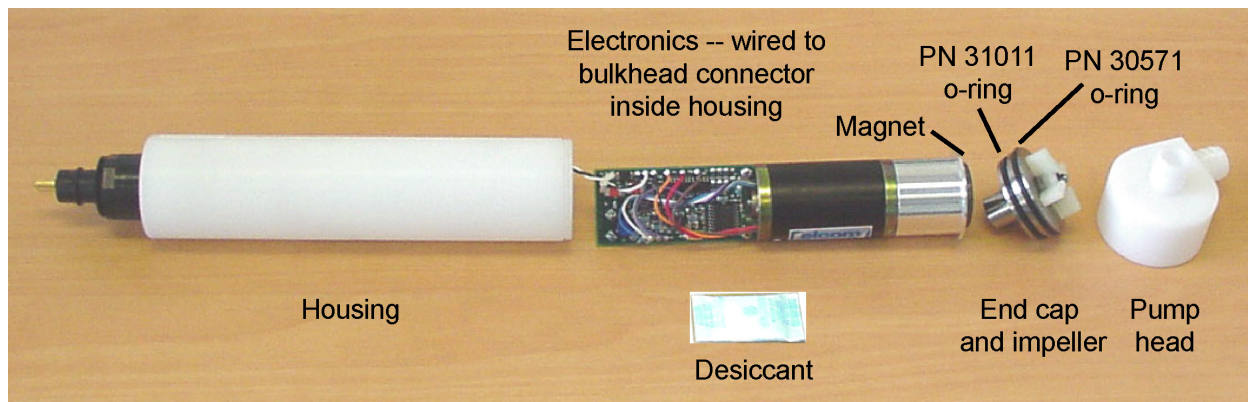
SBE 5P with Electronics Removed (**5T** similar)
